Soil-structure interaction of a pile wall at the toe of a natural slope

J. Castro*, J. Cañizal*, J. Casanueva†, E. Varela*, J. Justo*, M. Miranda*, A. Da Costa* & C. Sagaseta*

*Group of Geotechnical Engineering, E.T.S. Caminos, Canales y Puertos, University of Cantabria

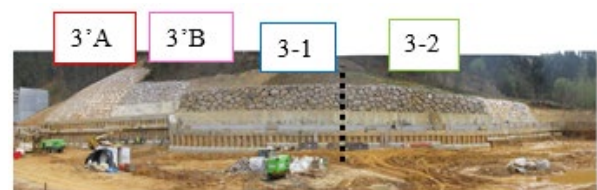
Figure 1. General view of the pile wall. Critical zone in April 2014, before reaching the maximum level of excavation.

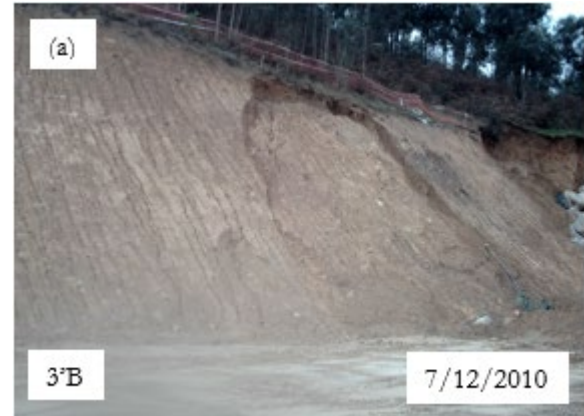
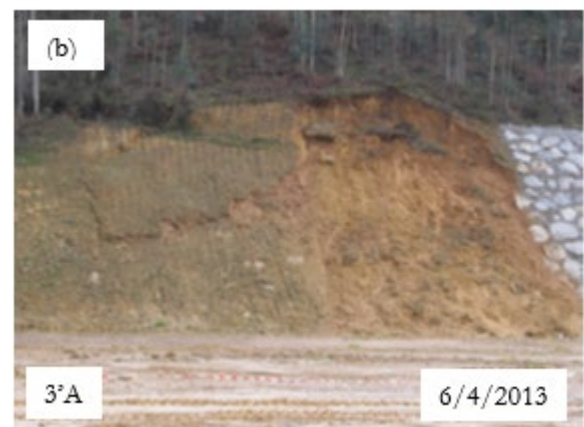
Figure 3: Landslides prior to the construction of the industrial unit. Top photo was taken on December 2010 and bottom one on April 2013.

(zones 3-1 and 3-2 of Figs. 1 and 2). On December 2010 and March 2013, two major landslides occurred near these locations. The first one was fixed building a riprap lining and, after a geotechnical study, an anchored concrete gravity wall was added at the lower part (zone 3'-B). The second landslide occurred after a heavy rainy period. The adopted correcting measures were to i) clean up the debris, ii) set back the slope 2-3 meters and iii) place a riprap lining above the anchored wall to refill the area (Fig. 1).

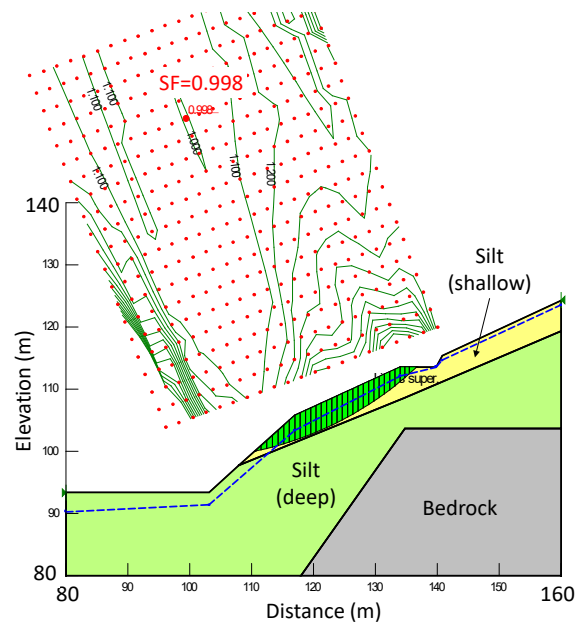
The analysis of the March 2013 slide allowed checking a critical slope stability situation (S.F. =1.00). A high ground water table (GWT) was considered, corresponding with the

Figure 4. Back-analysis of March 2013 landslide.

heavy rain situation of the period. The failure surface was observed to be 3-4 meters deep, same as a preferential water flow surface sub-parallel to the slope. The material of the slope was considered to be more altered at the surface and, therefore, in the limit equilibrium analyses, two different materials were used, one for the first 5 meters with a lower cohesion (5 kPa) and the remaining soil mass with a higher cohesion (20 kPa) (Table 2). Both materials have the same friction angle. This distinction allowed taking into account that, on the lower part of the slope, while the levelling works were under way, the superficial layer of soil was removed. Thus, the existing soil should have the characteristics of the deeper material. This explains how the slide did not affect the toe of the slope, as it was observed during its stabilization.

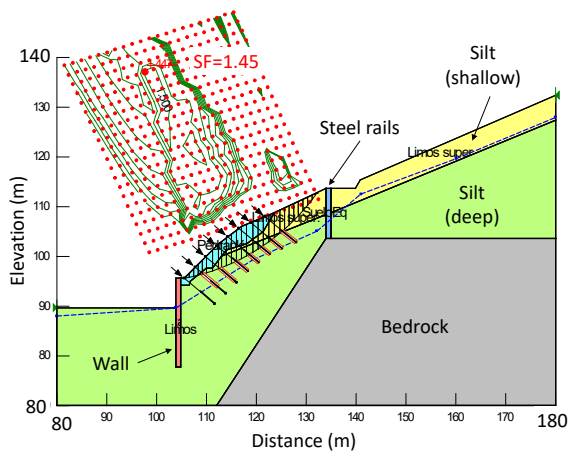
Figure 5. Stability analysis of the slope with corrective measures (horizontal drains, steel rails and bolted mesh of steel cables). Shallow slip circle.

As it will be seen further into the article, on April 2014 during the excavation of the basement of the northwest side of the building, the monitoring results indicate worrying movements on the slope. This critical stability situation was confirmed by the limit equilibrium analysis (S.F. =1.12). The 3'A wall section was taken as critical for the entire analysis (Figs. 1 and 2). Given the geometry of the slope and the location of the bedrock, it is expected that the failure surface will neither go under the wall or through it, for the high resistance of the concrete (Φ 1000 piles, spaced 1.10 to 1.20 m). Therefore, the length of the retaining wall and the ground anchors are not relevant for the analysis and so, the wall was modelled considering only concrete resistance (Fig. 5).

The low safety factor value for these shallow slip circles is consistent with the registered movements on the targets that were located on this lining zone. For all that, it was considered necessary to set a steel mesh fixed by long bolts over the riprap. This solution permits an increase in the slip safety factor of the shallow

circles up to similar values of those of the deep circles and close to 1.5 (Fig. 5).

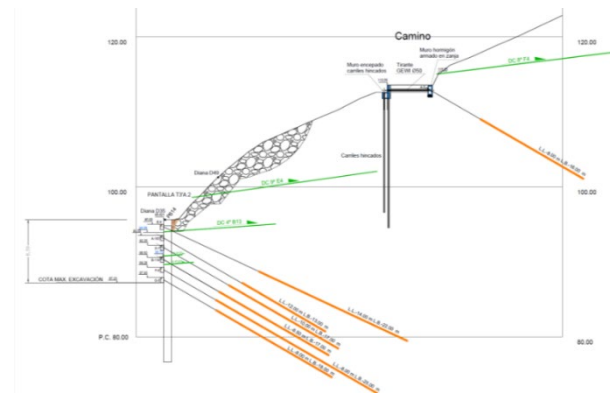
Figure 6. Sketch of corrective measures (long bolts and mesh of steel cables not shown).

- Lowering of the groundwater table with sub-horizontal drains with an

approximate length of 25 m in two areas: on the higher path and on the top of the wall.

- Executing a wall of driven rails braced by the top with an anchored concrete beam. This solution was proposed because the path is an easy access point for trucks. Moreover, a few cracks were registered on the path, consequence of the landslides, and it was a quick way to protect it.

The driven rails were arranged in two staggered rows spaced 0.6 m and 1 m between rails. The rails were 54 kg heavy and 5.8 m long. The planned length of each rail was 10 m but refusal was achieved between 7 and 30 m due to the irregularity of the bedrock location. The rails were placed on the side of the path. Given the impossibility of executing the anchors in that area, they were done on the inside (superior) margin of the path (Fig. 6). Seven anchors of 40 T, spaced 3.5 m, were disposed. Their inclination was 30°, with a free length of 8 m and a bonded length of 16 m. A concrete beam braced the heads of the anchors and this beam was then

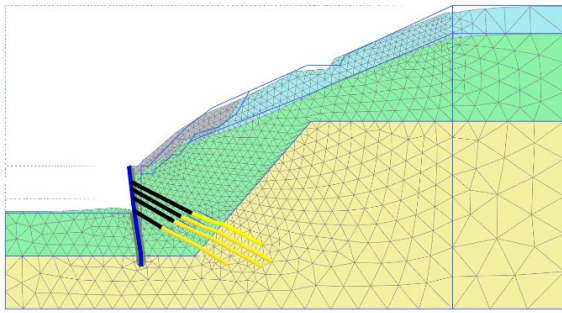
Figure 8. Finite element model and mesh. Predicted displacements (amplified by a scale factor of 20) in April 2014 (before adopting corrective measures).

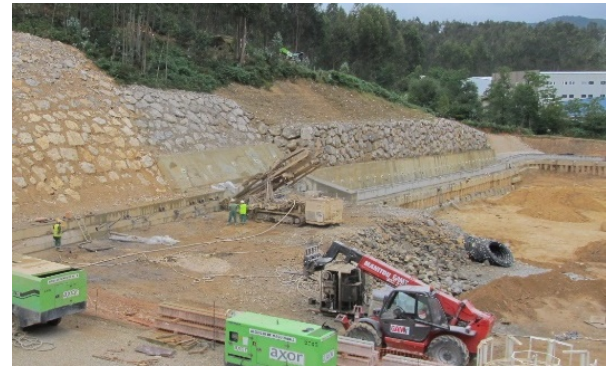
Figure 9. Execution of the top row of ground anchors with temporary pile wall protection and backfilling of the excavation.

installed at the level of the excavation on April 2014. However, the following analyses show the need for an additional row at the head of the wall (TopR) to discharge the initial anchors, which loads had increased notably. The execution of this superior row required the use of plastic and geotextiles for protection, as well as backfilling up to the top of the wall (Fig. 9). This was a satisfactory solution, as the load measures at the anchor heads lowered. Furthermore, the coincidence between the measurements and the predictions given by the numeric model has been adequate throughout the different phases of excavation and anchor execution (Fig. 10).

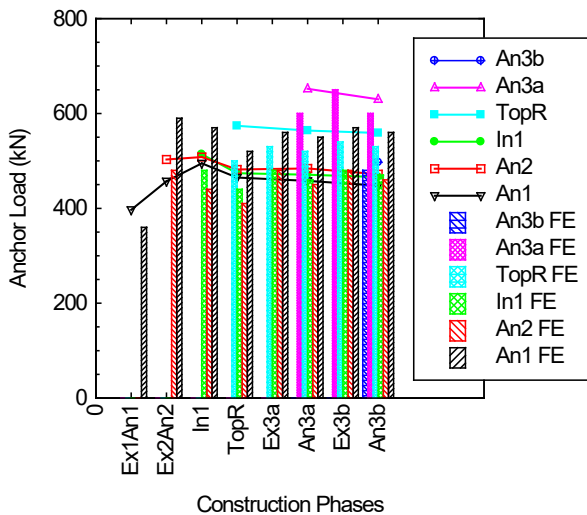
The finite element analyses helped to prove the precarious stability situations of the slope and the increase in anchor loads. In the design stage four rows of anchors (named An1, An2, An3a and An3b) were planned and based on the performed analysis it was decided to add two additional rows (In1 and TopR). The first additional row, the intermediate In1, was

Figure 10. Anchor loads during construction process. Comparison between finite element simulations and measured values.

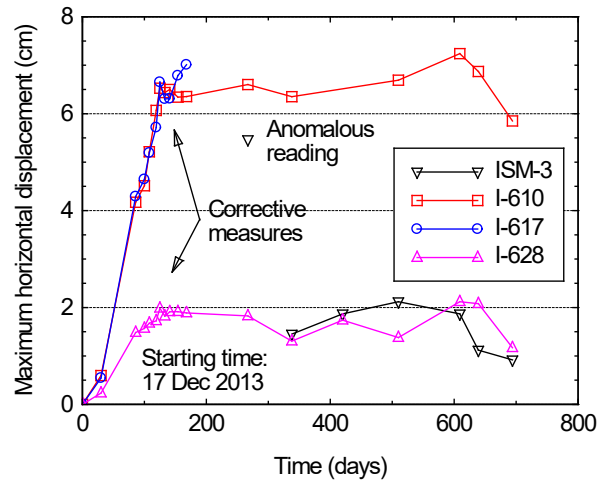
Figure 11. Evolution of maximum horizontal displacements measured at the inclinometer pipes.

The movements measured with the inclinometer pipes and the targets were notable until May 2014, with horizontal displacement rates up to 0.5 mm/day in the inclinometer pipes I-610 and I-617 (Fig. 11). This rate is in agreement with the safety factor calculated by limit equilibrium ($S.F. = 1.12$) [6]. The measurements of horizontal displacements at the I-610 and I-617 inclinometer pipes showed maximum values at the top and null at the level of the bottom of the pile wall. This indicated a correct embedment of the pile wall and slope stability issues at its back.

Around the summer of 2014 the main corrective measure proposals were carried out (long sub-horizontal drain pipes, additional anchor rows, and driven rail wall in the slope), which helped to stabilize the movements since May 2014. From that date, the registered movements are practically constant (Fig. 11), but for slight oscillations. These could be attributable to seasonal movements, the accuracy and precision of the measurements or some additional works, such as the installation of the steel mesh fixed by long bolts in the summer
