# Analysis of the damage caused by a fire in the formwork of the bottom slab of a liquefied natural gas storage tank

This paper presents the results of the study carried out on the structure of the bottom slab of a liquefied natural gas tank (circular slab 89 m in diameter and 1.20 m thick, raised 2 m above ground level, and supported by circular piles 1.20 m in diameter), in which a fire in the formwork affected both the slab and the piles. Concrete in these elements, apart from having a very high moisture content at the time of the fire, was also a very compact material - it contained 50% blast furnace slag, GGBS - which, together with the compressions generated on the surface of the slab and the supports by the effect of the fire, caused significant damage in some areas which, in any case, could be repaired using conventional techniques.

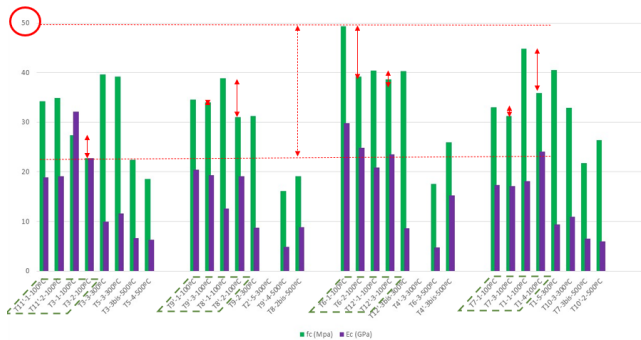
As an example, figure 12 illustrates the results obtained in compressive strength and elastic modulus determinations of samples from the columns.

As can be observed, there is significant dispersion for each temperature. There is also a significant dispersion in concrete resistance between the outer sample (no. 1) and the closest inner sample (no. 2) for 100 °C treatment. It is to be noted that the strength of the columns was, in every test, under the characteristic value (50 MPa). This did not occur in cores obtained from the slab. This difference will be discussed later.

**Figure 12.** Columns. Mechanical properties of concrete. Each group corresponds to different level of damage

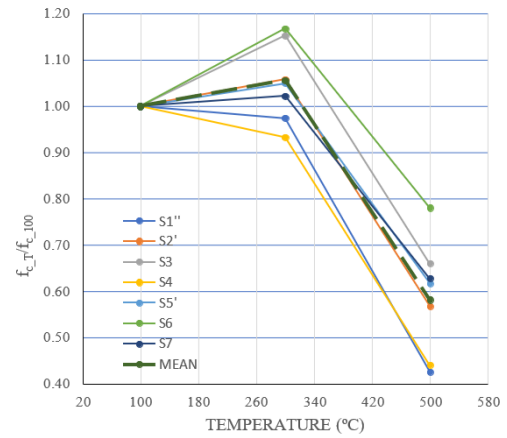
It could also be observed that, as expected, the elastic modulus reduces faster (to 40% at 300 °C and 30% at 500 °C, compared to 100 °C) than the strength, which only drops after treatment at 500 °C (to about 40%). Figures 13 and 14.

deterioration tends to occur at temperatures above 400 °C, retaining its structural properties up to 600 °C ([1], [2]). The 40 % drop of strength at 500 °C is higher than expected.

**Figure 13.** Slab. Concrete strength. Furnace treatment

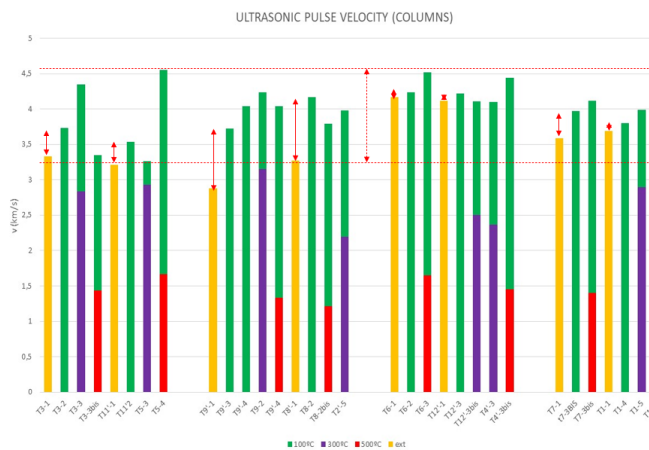
Figure 15 illustrates the results obtained in the test in samples from the columns and the slab. The dispersion in the results of the columns ( $\sigma/\mu \approx 0.1$ ) is the usual in this kind of tests.

As expected, the UPV is notably reduced at 300 °C (around 30 %) and 500 °C (around 65 %), consistent with the reduction in elastic modulus shown earlier.

Regarding the external cores, the reduction of the UPV at the exposed faces is quite moderate in practically all cases, particularly when results are compared with those at 300°C. There is no clear relation between the reduction and the damage level.

Figure 15. Columns. UPV. Each group corresponds to different level of damage

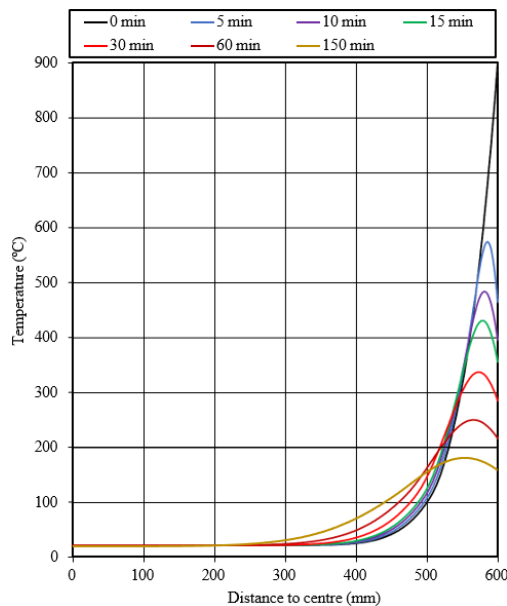
The maximum depth with temperatures higher than 200 °C obtained was of 70 mm at 60 minutes, with a slight increase during cooling according to Figure 16.

**Figure 16. Columns. Temperature distribution after the fire event**

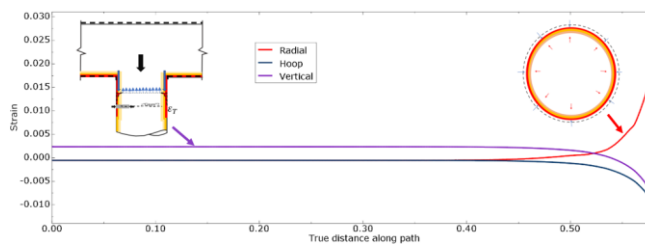
In the mechanical model, it is assumed that the sections remain plane, allowing axial strains. The distribution of the stresses after 60 min fire are presented in Figure 17. It is worth clarifying that no softening was included in the tensile behaviour of the concrete, in order to assess the cracking pattern. According to the calculations, horizontal cracks are expected in the inner part of the column after 5 minutes.

**Figure 17. Columns. Stress distributions after 60 min fire**

- The only minor exception is the central part of the columns. Heating the outer layers of the columns entails their longitudinal compression (by thermal expansion) and associated tensions in the central region. This is likely to have caused some tensile cracking along horizontal planes, which would explain the difficulties experienced in getting continuous cores from the columns and the lower mechanical properties encountered.

When the outer concrete is repaired, some horizontal cracks are likely to remain in the central region of the columns. Nevertheless, this is unlikely to affect the structural performance and is not deemed to have structural consequences, since the cracks will be compressed.

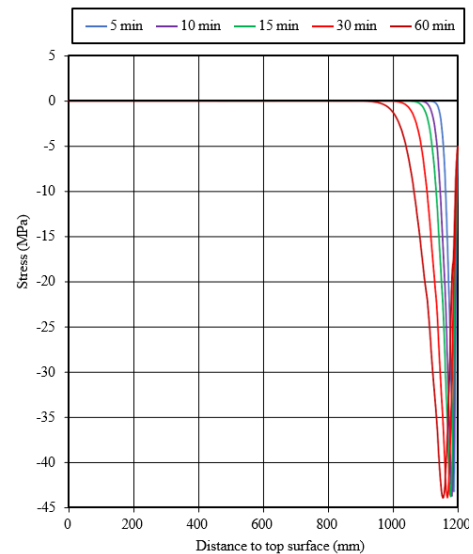
The maximum depth with temperatures higher than 200 °C is 70 mm after 60 minutes, with a slight increase during cooling, very similar to what happened with columns. For this scenario, it is reasonable to assume that the slab region not thermally affected, together with the restraining action of the piles, prevents the global elongation of the slab. The distribution of the

stresses at different times are presented in figure 18. According to the calculations, no cracks are expected beyond 100 mm near the bottom surface.

**Figure 18. Slab. Stress distributions during the fire**
