Flexural capacity of corroded post-tensioned concrete beams: large scale tests and numerical simulation

Antonino Recupero^a, Nino Spinella^b, Antonio R. Mari^c, Jesús M. Bairán^d

An experimental campaign was carried out at the University of Messina to study the influence of the tendon corrosion on the response of post-tensioned concrete beams under transversal loads. Six beams were cast in 2006 and subjected to induced corrosion of the tendons by injecting a chemical solution or an acid in some parts of the duct. The results showed that the load bearing capacity was reduced up to 50%, with respect to the tested un-corroded beam. The tests were simulated by means of a non-linear time dependent analysis model, developed at UPC, showing its capacity to capture the effects of corrosion along the time and to estimate the degree of corrosion

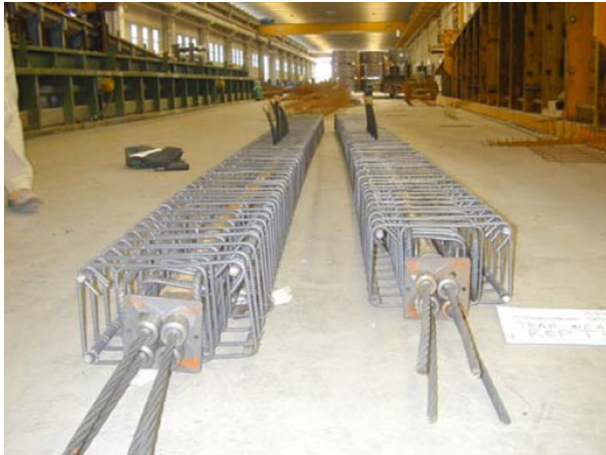
Figure 1. Reinforcement setup.

The PC specimens had a rectangular shape (400×250 mm) and a total length of 6300 mm. Prestressing was carried out using 4 tendons of 7-wire 0.6” strands, and steel with an ultimate tension capacity of $f_{ps} = 1860$ MPa was used. The cable was placed along the

centroid axis (Fig. 1). The longitudinal reinforcement was achieved with $2\phi 18$ both at top and bottom of the cross-section. The transverse reinforcement was realized with closed stirrups $\phi 8/100$ mm, except for a closest spacing (80 mm) at the ends of the beam and for a transfer length of 800 mm (Fig. 1). The FeB44k steel rebar was used, with a minimum yield strength of 430 MPa.

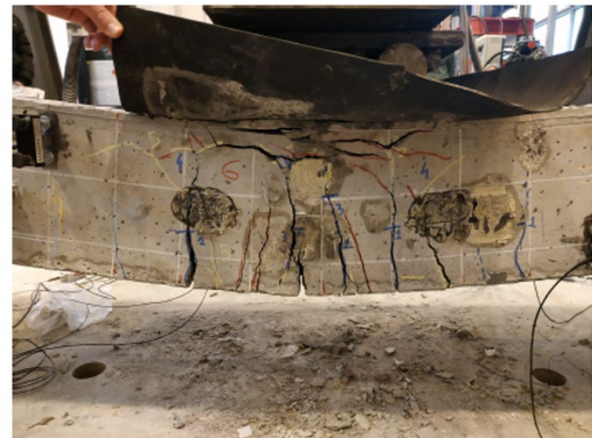
Figure 5. Crack pattern at failure of beam T3a.

The beam T3a was damaged with a hole inside of the duct at 1/2 of the beam length. A chemical solution was injected in the small tank, 100 mm long, to cause a localized corrosion of the tendon. The test was performed under displacement control, and seven cycles were executed at the following displacement levels: 10, 20, 40, 60, 80, 100 and 140 mm.

The response behavior has been also linear until a maximum load of less than 60 kN, see Figure 5.

It is almost half of the bearing load achieved by the T1 beam. At the fourth cycle the maximum load bearing capacity of the beam (about 60 kN) has been recorded. The force peak has been followed by a load abruptly decay, and a typical noise of steel breaking has been heard. Probably a strand broke or frayed,

in fact the next cycles have been characterized by both lower stiffness and load, with subsequent drops of force. The corrosion in the middle of the tendon has drastically changed the capacity of the beam.

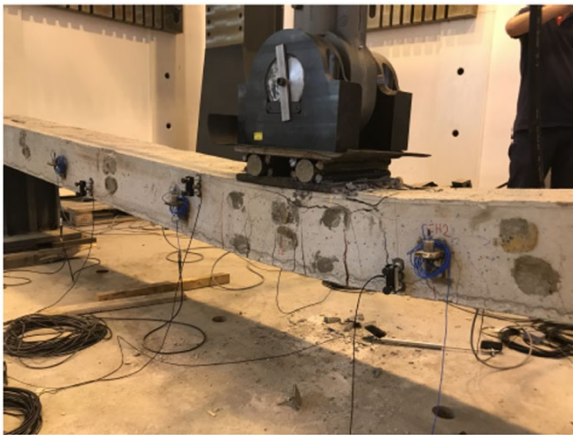
Figura 6. Crack pattern at failure of beam T4a.

This specimen was damaged with a hole inside of the duct at 1/4 of the beam length. A chemical solution was injected in the small tank, 100 mm long, to cause a localized corrosion of the tendon.

The response behavior has been almost linear until a load less than 50 kN. At the fourth cycle, the stiffness decay, and the load-displacement curve showed a new branch with different slope. The last cycle has allowed to achieve the maximum load bearing capacity of the beam (more than 60 kN), followed by two subsequent drops of force.

The test has been performed under displacement control, and six cycles have been carried out: 10, 20, 40, 80, 100 and 200 mm, respectively.

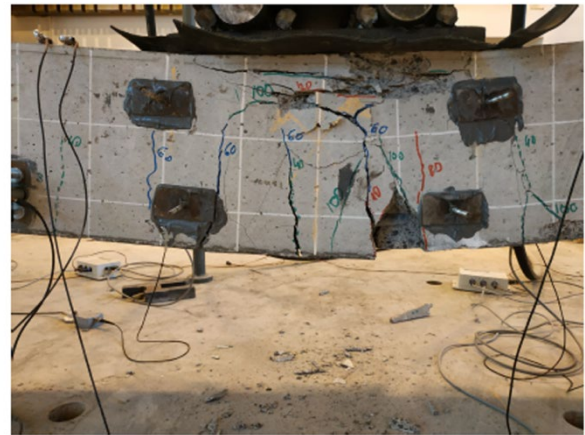
Figura 7. Crack pattern at failure of beam T6a.

The beam T6a was prestressed with an un-bonded tendon and, then, the duct was filled with grease injections at 1/6, 1/2 and 5/6 of the beam length, respectively. In the empty parts of the duct, a mould was introduced to cause a spreading corrosion.

The response behavior has been almost linear until a load less than 100 kN. It is a smaller value than the same load recorded for the T1 beam.

At the fourth cycle, the stiffness has decayed, and the load-displacement curve showed a new ascending branch with a different slope. Then, at the sixth cycle (100 mm), the maximum load bearing capacity of the beam (about 120 kN) has been reached.

The test has been carried out under displacement control, and height cycles have been performed by applying height displacement levels: 10, 20, 40, 60, 80, 100, 120 and 150 mm, respectively.

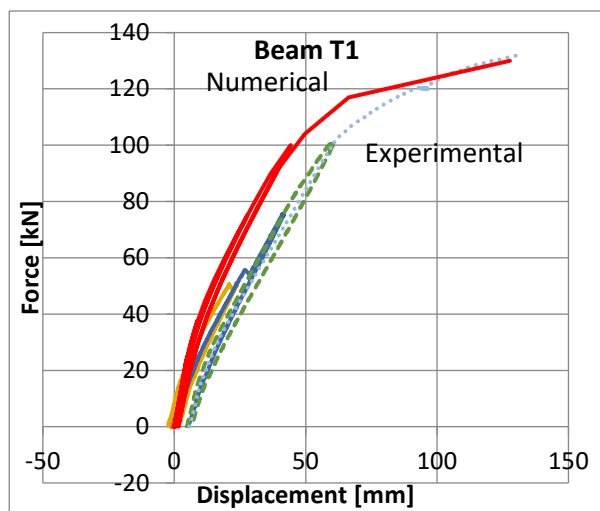
Figure 10. Load-displacement curves, beam T1

Figure 10 shows the experimental and numerically obtained load-deflection curves of beam T1, without induced corrosion.

Load control was used in this test, for the six loading and unloading cycles until reaching 25, 50, 75, 100, 130 and 150 kN. The ultimate load found was 130 kN, therefore, only 5 cycles are represented in Figure 10. It is observed that the ultimate capacity is very well captured by the numerical model, although the experimentally measured deflections were higher than those numerically obtained.
