Installation of the 4 main steel trusses for the extension of the Anoeta Football stadium, San Sebastian - Spain.

ABSTRACT

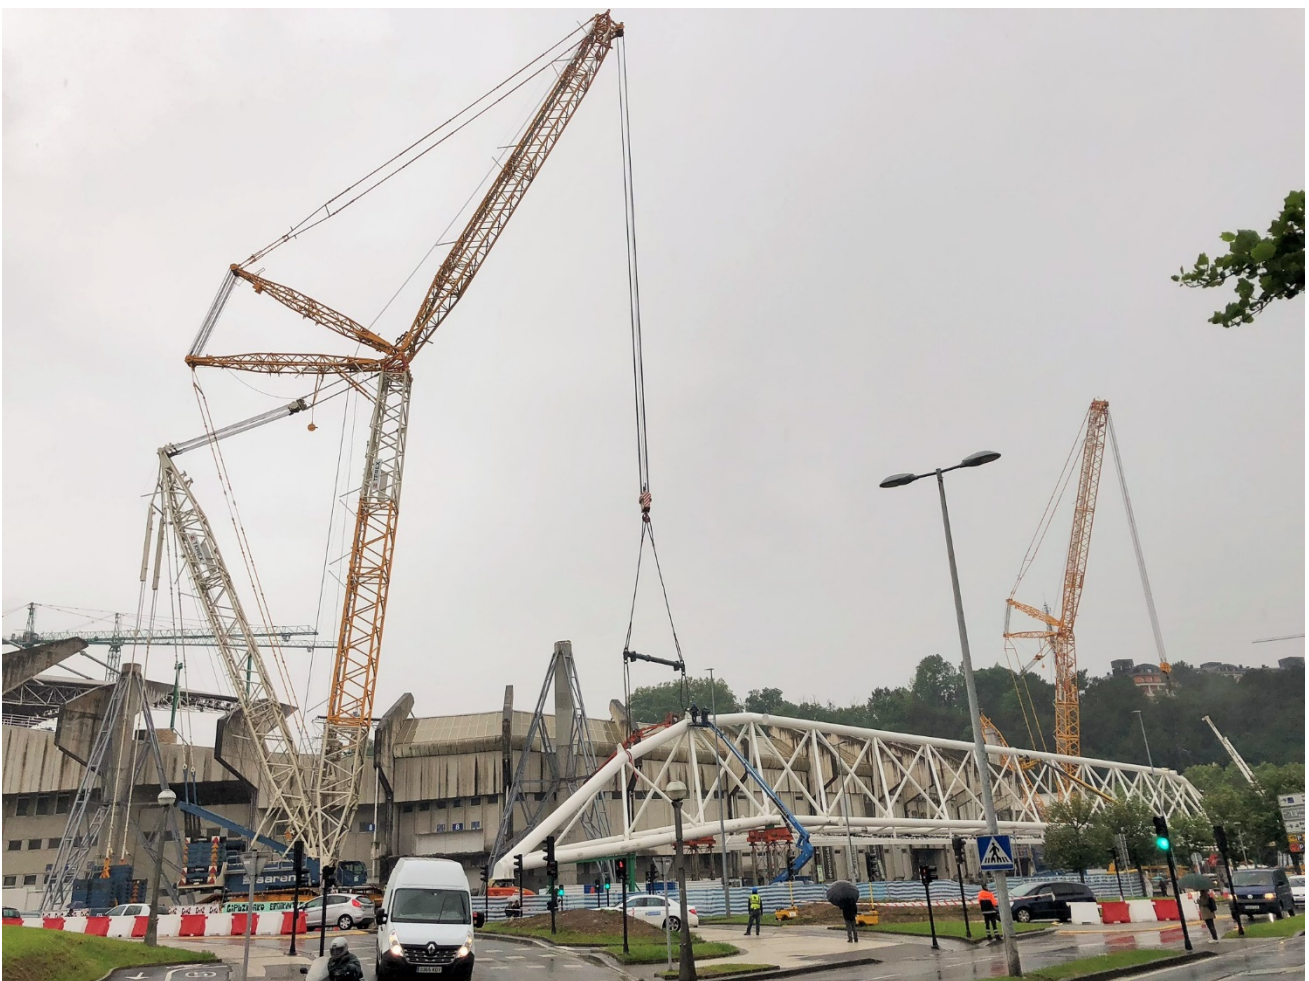
Figure 1: Initial position of the cranes for taking the load.

On the following pictures the reader can see a sequence of pictures showing how the first of the four trusses was installed (North one).

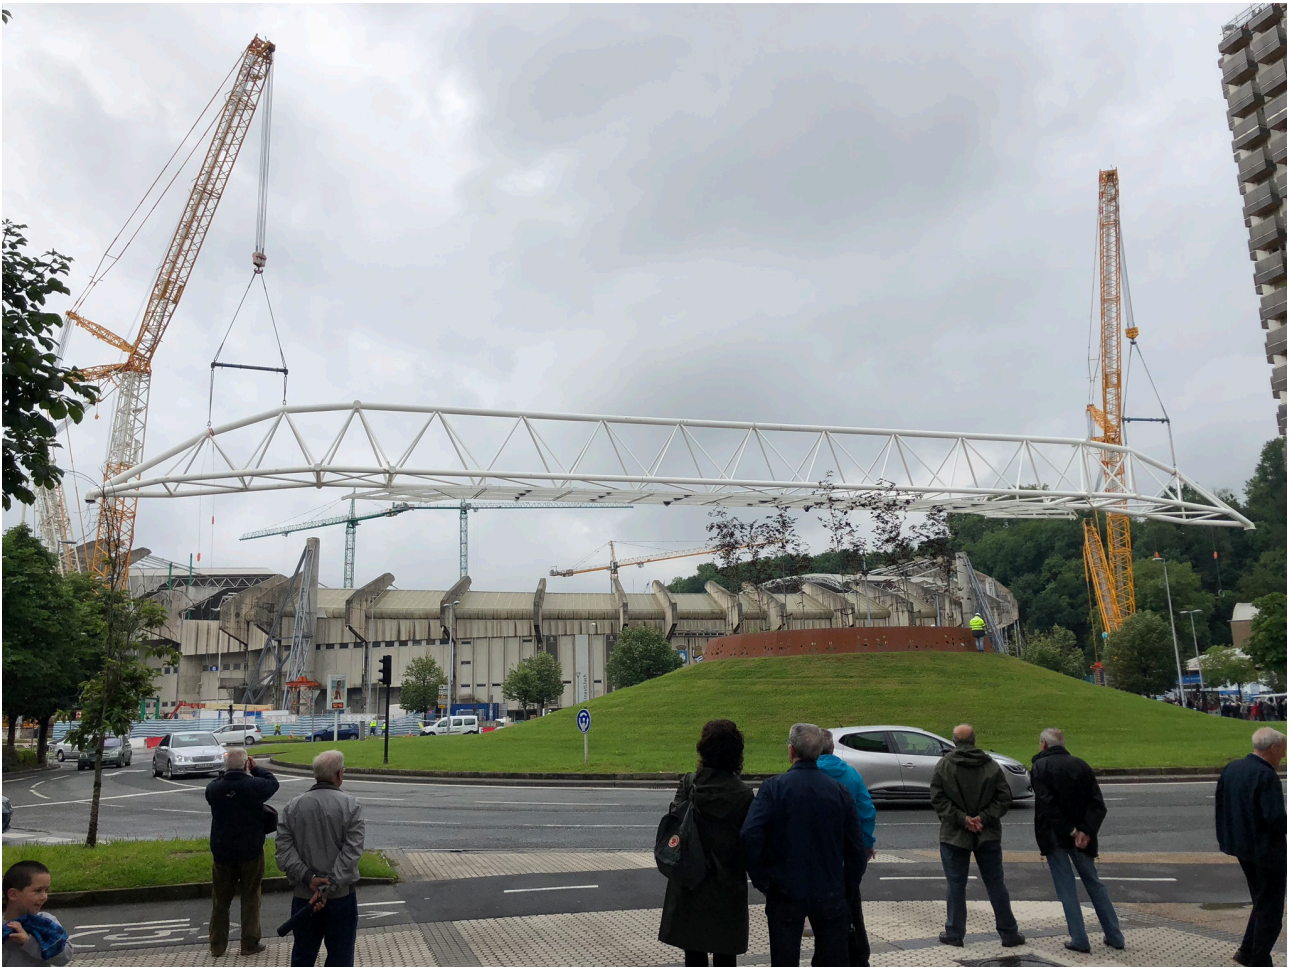
Figure 2: Intermediate position of the cranes with the truss still out site the stadium.

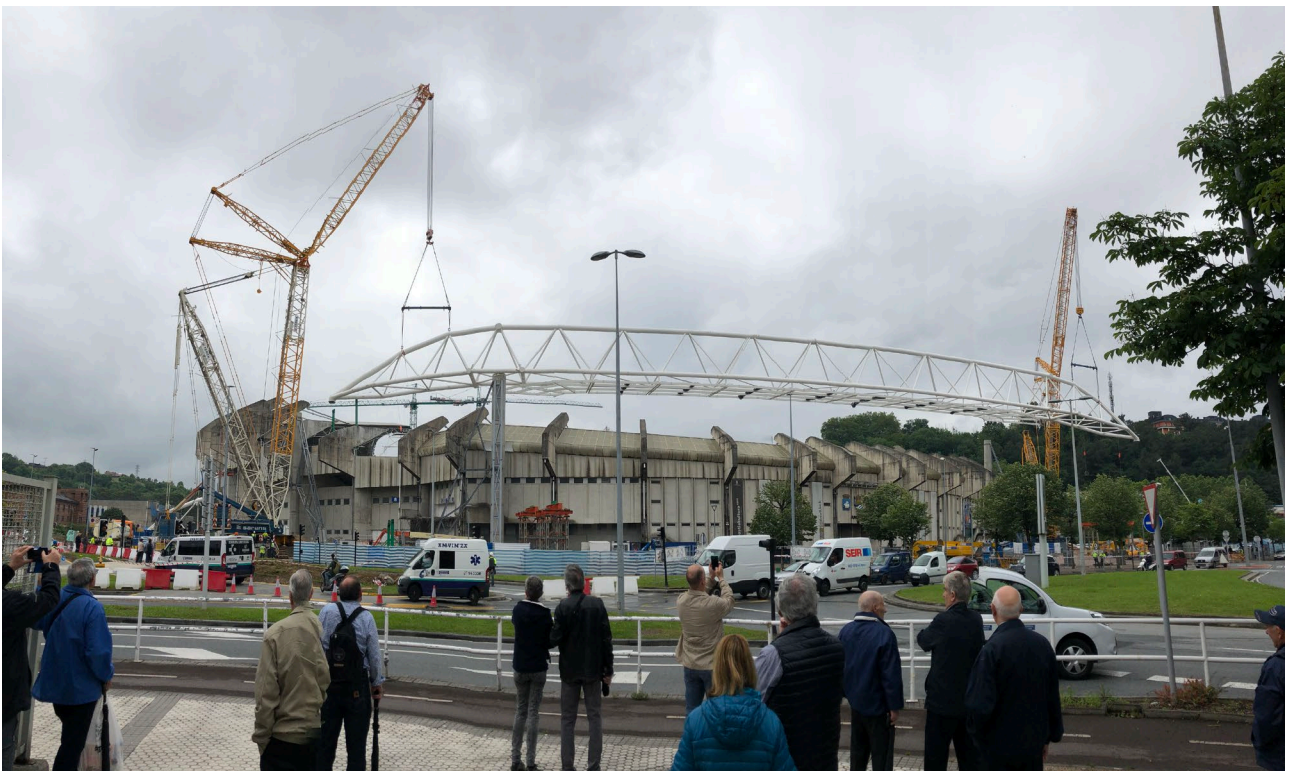
Figure 3: Intermediate position with the hook of one crane (left) already inside the stadium.

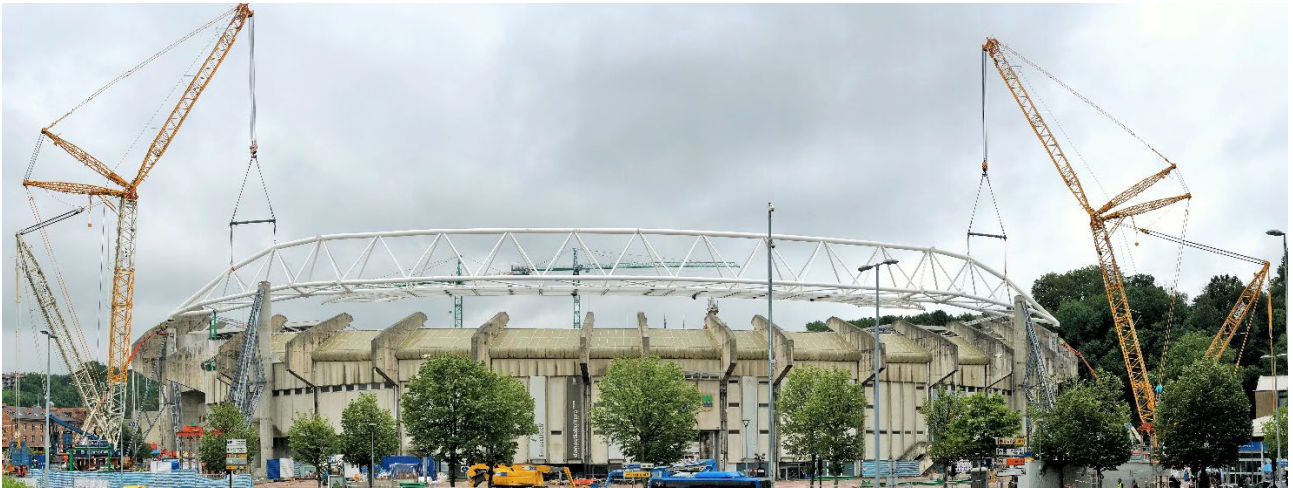
Figure 4: Final position.

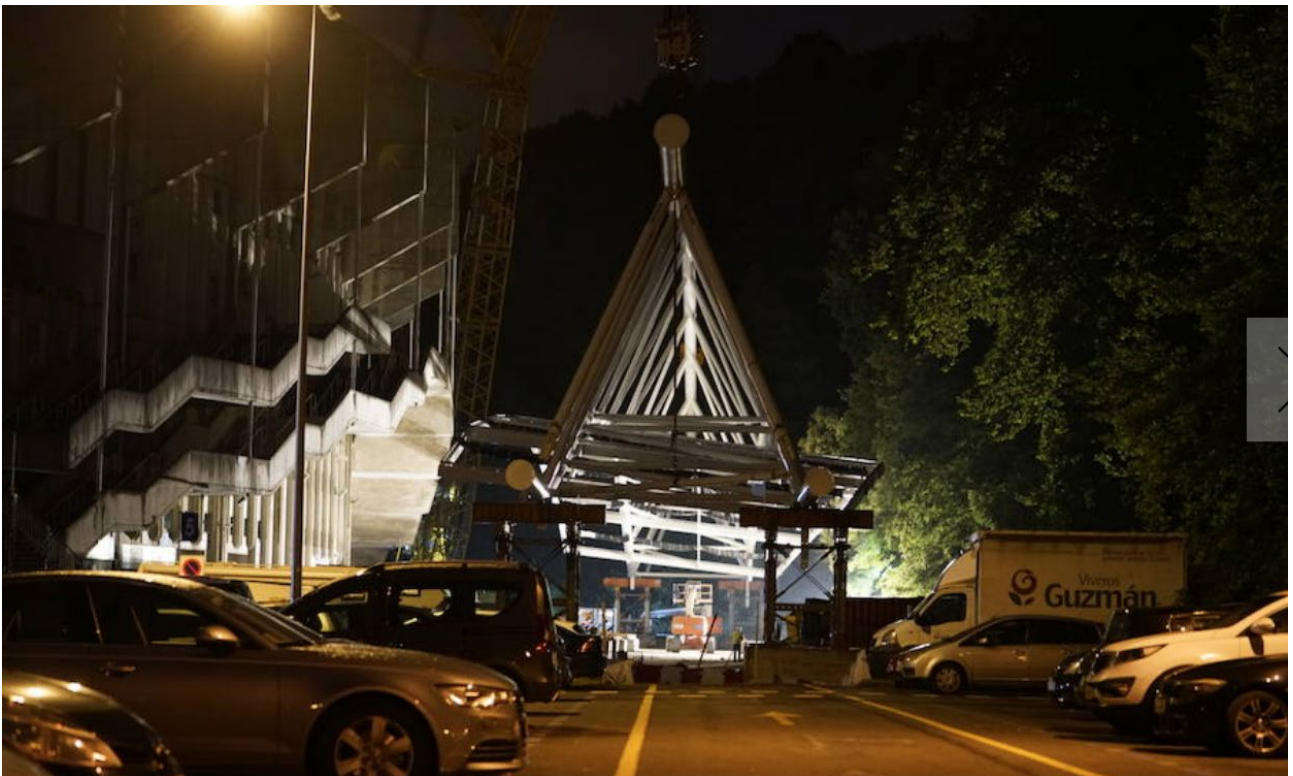
Figure 5: Initial position of the truss still resting at road level. Starting at dawn.

The main reason why these types of cranes were selected was that for the installation of the West Truss the required crane in its south corner outside the stadium was constricted among the mountain at the side of the stadium and all the civil constructions surround it. A smaller crane at this spot was not strong enough, and a bigger one was not fitting in the available area.

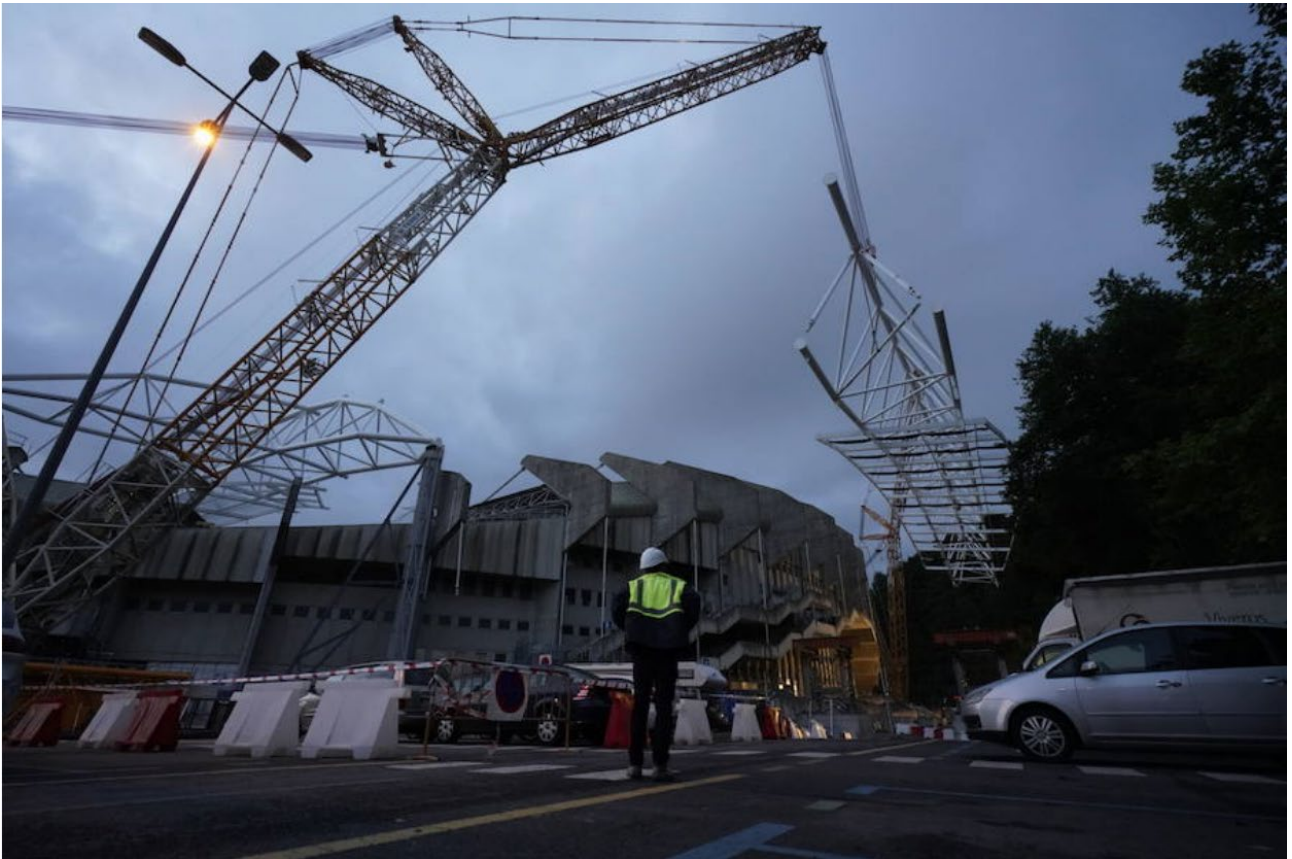
Figure 6: Intermediate position of the cranes with the truss still out site the stadium.

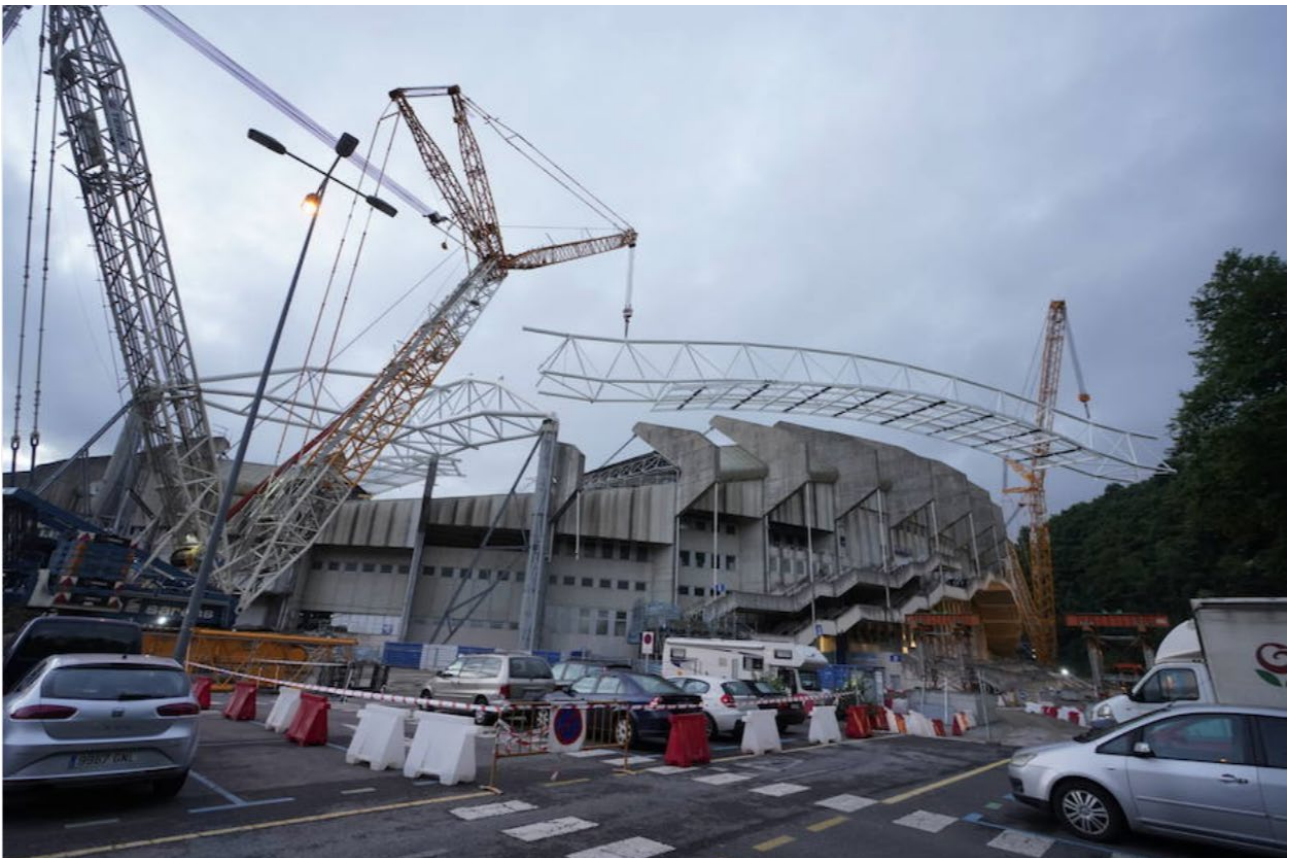
Figure 7: Intermediate position with the hook of one crane at the left already inside the stadium.

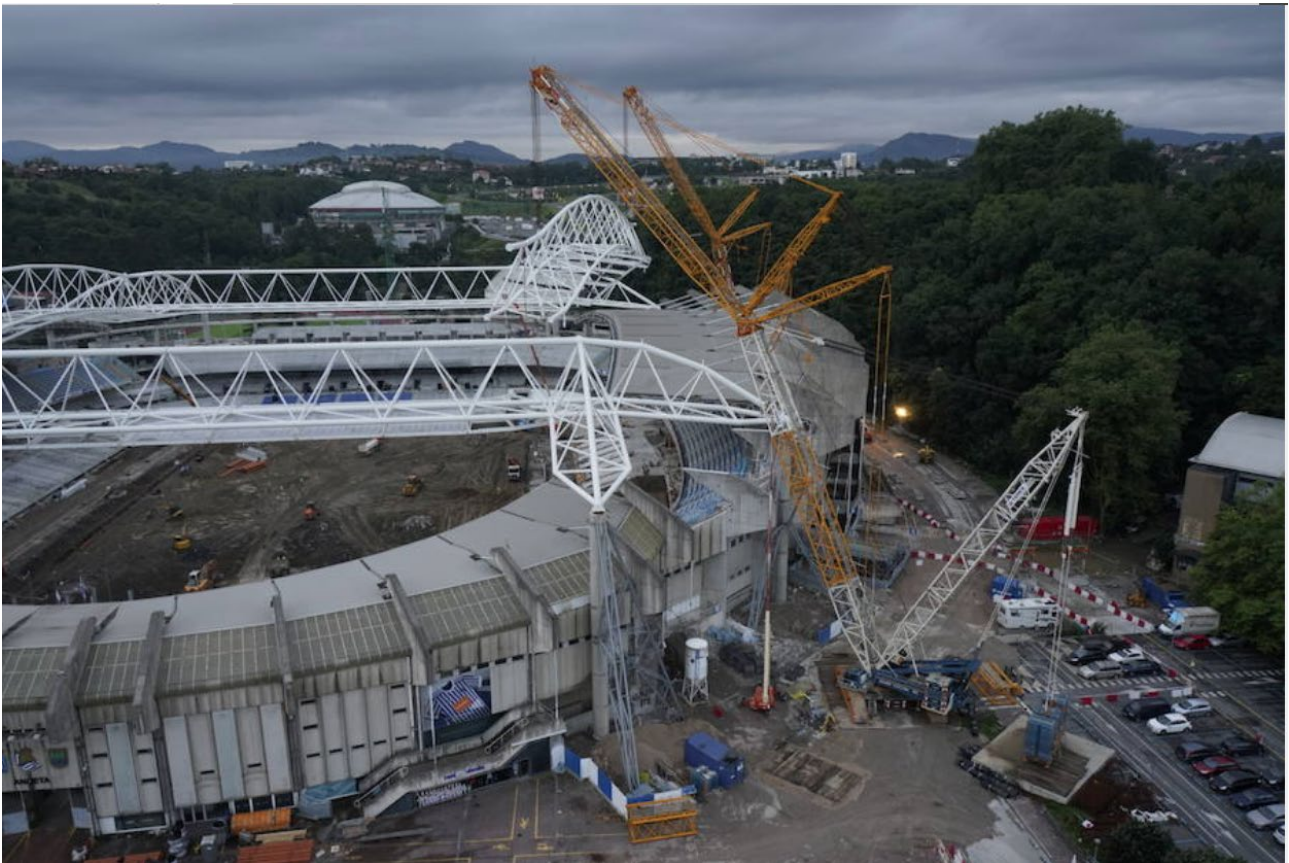
Figure 8: Intermediate position with hooks of both cranes already inside the stadium.

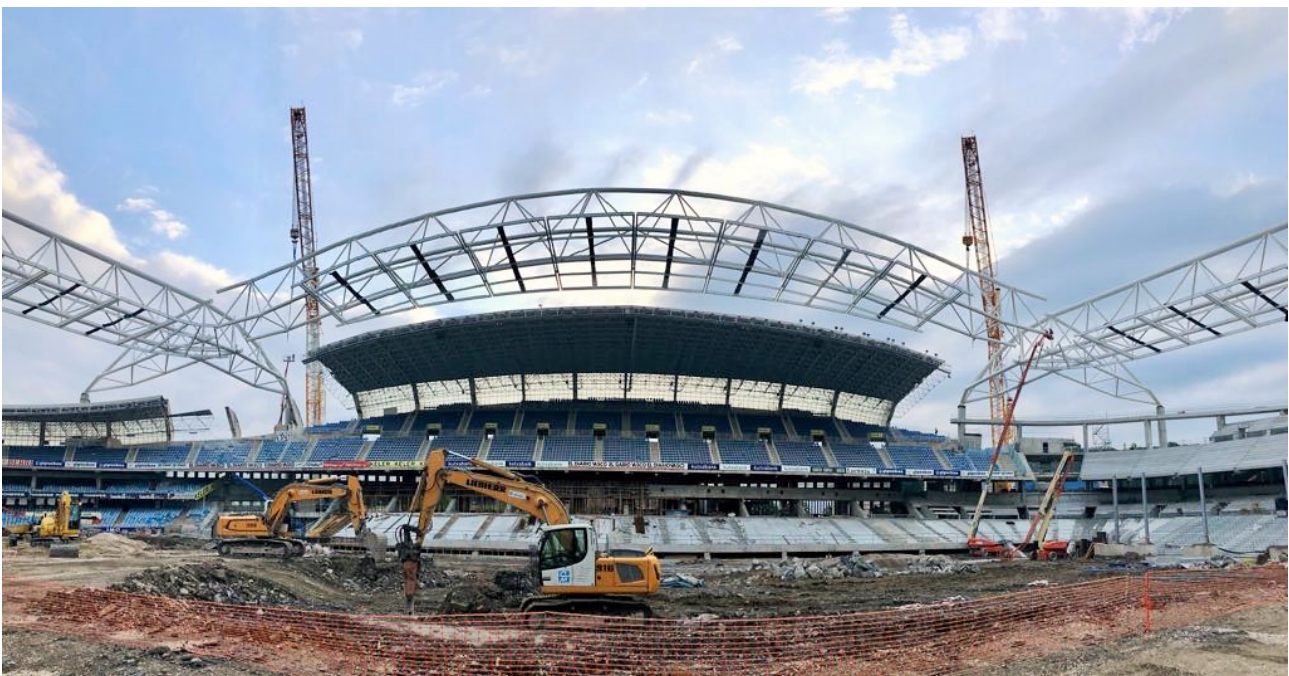
Figure 9: Inside view from the pitch right before final position. Also, visible other subcontractors working to lower the level of the pitch so the new seats over the former athletic truck can see it.

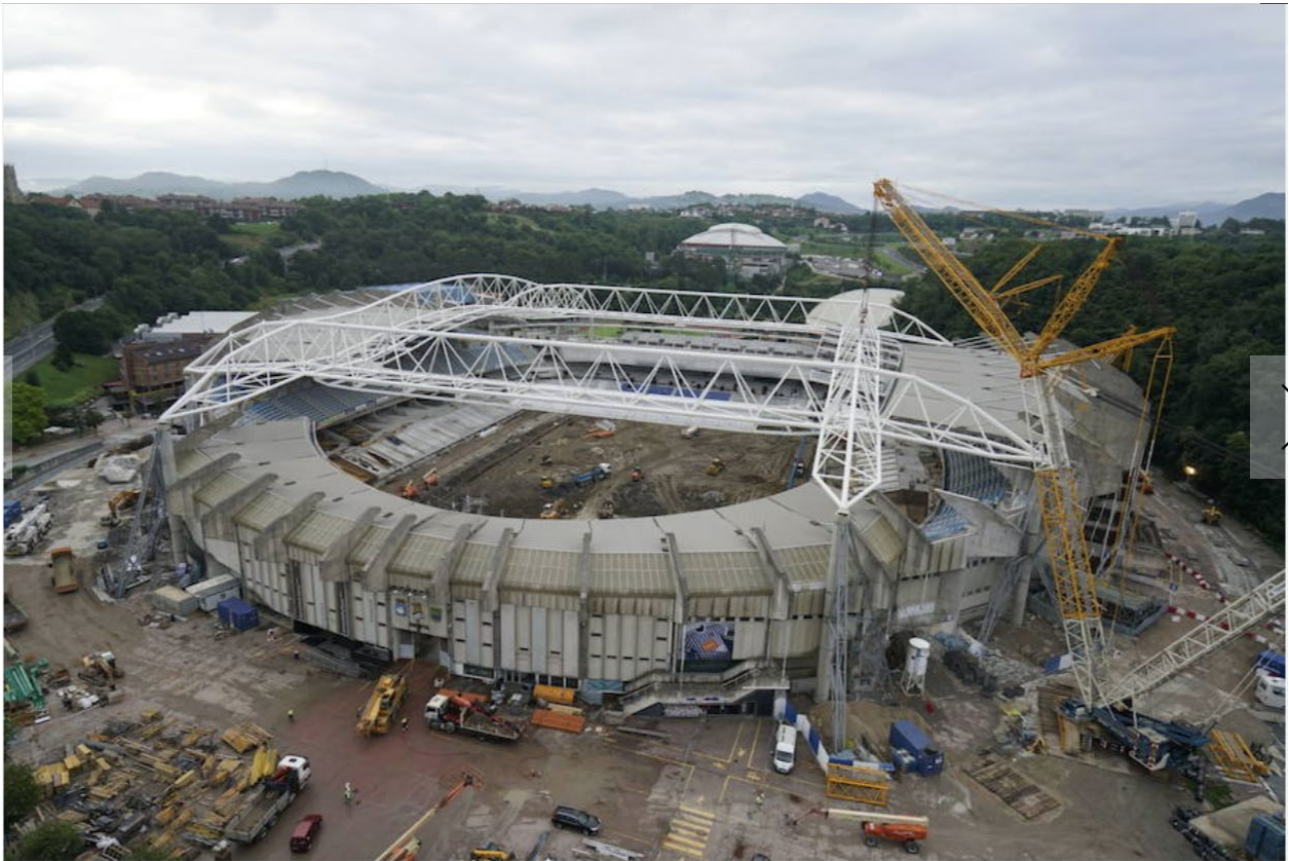
Figure 10: Final position. General view of the stadium with the 4 new trusses already installed.
