# Comportamiento a flexión del hormigón armado con barras de acero y fibras de polipropileno en condiciones variables de carga y fisuración sometido a la penetración de cloruros

*Flexural performance of reinforced concrete with steel rebar and polypropylene fibres under various loading and cracking conditions subjected to chloride ingress*

Petar Bajić<sup>a</sup>, Bruno Leporace-Guimil<sup>b</sup>, Carmen Andrade<sup>c</sup>, Nikola Tošić<sup>d</sup>, Martin Hunger<sup>e</sup>, Albert de la Fuente<sup>f</sup>

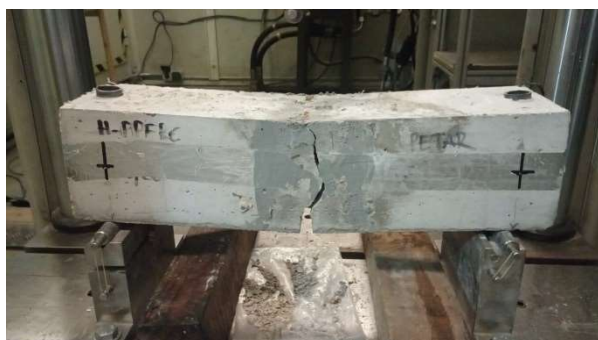
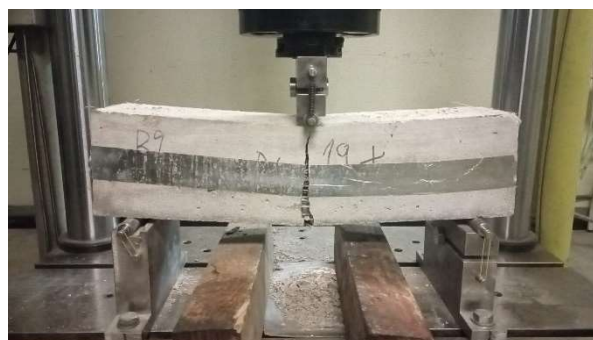
All elements were observed to fail in flexure (Figure 6), however with significant differences between corroded and uncorroded elements.

Figure 6. Typical observed failure a) corroded beam, b) uncorroded beam

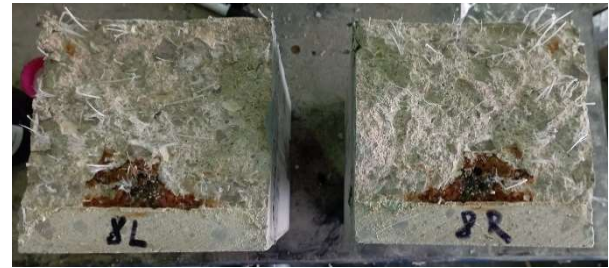
Effects of chloride corrosion were clearly visible on the cross sections of elements after destructive tests were performed. The red-brown area in Figure 8 indicate deposits of corrosion products, whereas white parts surrounding it indicate zones where chlorides reacted with the  $\text{AgNO}_3$  solutions. In Figure 9, the cross section may be observed to be clean of both corrosion products and chloride

**Figure 8. Typical cross section of a corroded beam (pre-cracked and exposed)**

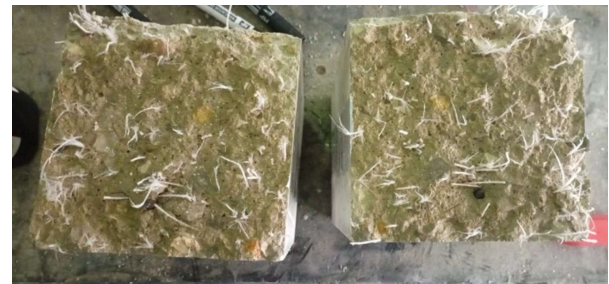
penetration, thus, this confirming that the rebar remained passive.

**Figure 9. Typical cross section of an uncorroded beam (uncracked and exposed)**
