Soil-structure interaction of a pile wall at the toe of a natural slope

J. Castro*, J. Cañizal*, J. Casanueva†, E. Varela*, J. Justo*, M. Miranda*, A. Da Costa* & C. Sagaseta*

*Group of Geotechnical Engineering, E.T.S. Caminos, Canales y Puertos, University of Cantabria

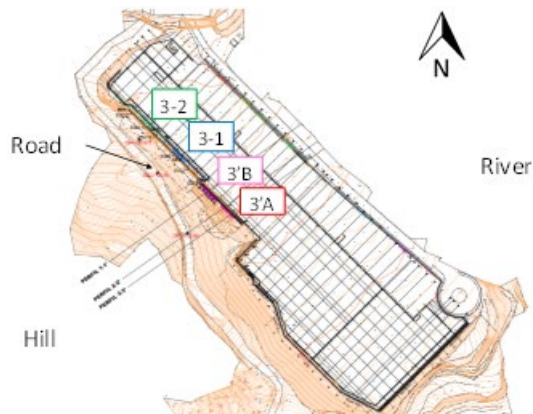
Figure 2: Top view of the industrial unit and the different zones of the pile wall under study.

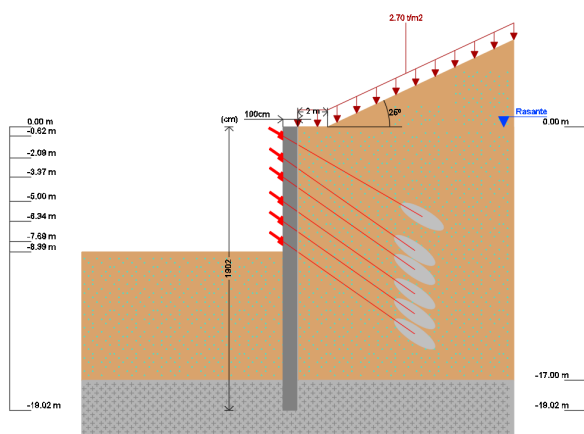
Figure 7. Soil-wall interaction model.

Another inconvenient is that CYPE cannot model the specific soil profile behind the wall because of the inclined layering and the irregular ground surface, which led to an oversimplification of the ground. As a first approximation, a simplified model was considered consisting in one silt layer, a horizontal bedrock and a superficial load behind the pile wall for the riprap lining (Fig. 7).
