# Analysis of the damage caused by a fire in the formwork of the bottom slab of a liquefied natural gas storage tank

This paper presents the results of the study carried out on the structure of the bottom slab of a liquefied natural gas tank (circular slab 89 m in diameter and 1.20 m thick, raised 2 m above ground level, and supported by circular piles 1.20 m in diameter), in which a fire in the formwork affected both the slab and the piles. Concrete in these elements, apart from having a very high moisture content at the time of the fire, was also a very compact material - it contained 50% blast furnace slag, GGBS - which, together with the compressions generated on the surface of the slab and the supports by the effect of the fire, caused significant damage in some areas which, in any case, could be repaired using conventional techniques.

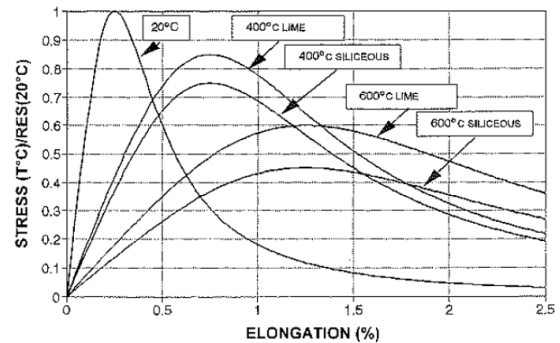
It could also be observed that, as expected, the elastic modulus reduces faster (to 40% at 300 °C and 30% at 500 °C, compared to 100 °C) than the strength, which only drops after treatment at 500 °C (to about 40%). Figures 13 and 14.

**Figure 14.** Usual concrete behaviour with temperature [1]

In relation to the above, it should be noted that high temperature behaviour has usually been studied for concrete made with Portland cement and siliceous or lime aggregates. There are fewer references for concrete using basaltic aggregate and 50% GGBS. Recent investigations ([4], [5]) suggest that GGBS seems to improve the resistance to fire conditions: when the exposure to fire temperature increased from 200 to 400 °C, the compressive strength increased for concrete with OPC/GGBS proportions of 70/30 and 50/50 -as concrete from the tank-, but with 30/70 the opposite was observed. Any case, concrete suffer a strong deterioration after 400 °C, as observed in the test (40% strength after treatment at 500 °C).
