Investigación sobre robustez de edificios de losas de hormigón armado

Research on robustness of concrete flat slab buildings

This paper shows the preliminary analysis of the test results of a real scale pilot building test carried out at ICITECH of Universitat Politècnica de València. The results are compared with theoretical predictions and discussed in the context of Eurocode tying requirements. Whilst the structure was compliant with these requirements the results suggest that the structure was able to sustain a sudden corner-column removal due to flexural slab deformations, helped by the Vierendeel behaviour, and without any significant activation of ties in this case and the infill masonry walls as a predominant alternative load path when these panels were considered.

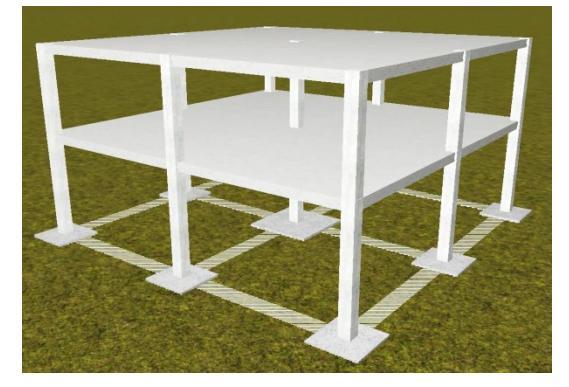
Figure 1. 3D view of the design.

A real-scale RC building was designed with only research purposes. This building had two floors of 2.8m height, four bays with 5.0m span length, flat-slabs 20cm thick and columns of 30x30cm². Prescriptions of Eurocode 2 [16] were adopted and a category of use corresponding to high occupancy buildings (C1, C2 o C3) [17] was chosen. In addition to the self-weight of the structure, a dead load of 2kN/m² and a uniformly distributed live load of 3kN/m² were considered in the design of the structure.

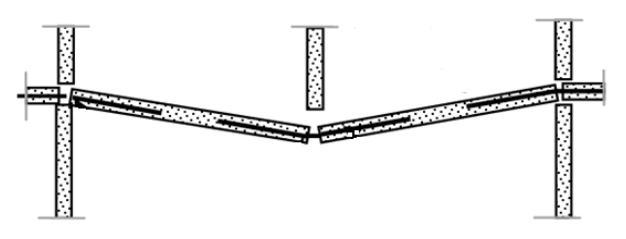
Figure 2. Example of horizontal ties working after an internal column loss.

The building belongs to a consequence class 2a (Lower Risk Group) following Eurocode 1, Part 1-7 [2], but it was categorized as a consequence class 2b (Upper Risk Group) as it is a test which aim is to reproduce the behaviour of high occupancy and taller buildings. At this point, the building was designed using the simplified methodology of the tying forces and elements (horizontal and vertical ties). A discussion about the origins and the validity of the tying simplified methodology is discussed in [6]. As a result, the design of the building was only slightly modified with respect to the design without accidental actions. This is a common trend when considering flat-slabs, as pointed out in [6]. Fig. 2 shows an example of horizontal ties working after an internal-column loss.

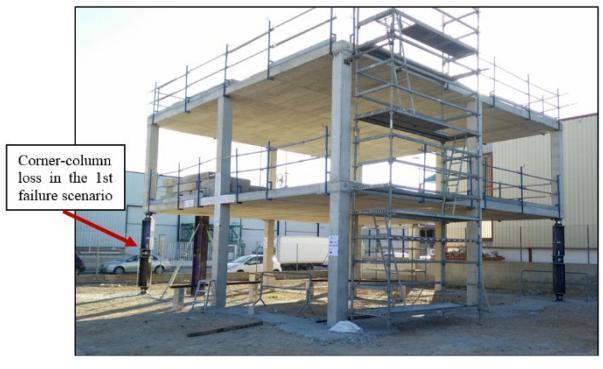
Figure 3. Building and definition of the first failure scenario.

Two experimental tests for two different failure scenarios were considered in this study. In both cases, a corner-column loss was considered, selecting two opposite corners columns to avoid the influence of a damaged structure in the second test. These columns were steel-based (HE-300B profile) prepared with a mechanism to reproduce a sudden failure. Only the structure of the building was tested for the first failure scenario, whereas infill masonry walls were also introduced for the second failure scenario. These masonry walls were only constructed in the first floor and in those modules with more influence in the defined corner-column failure scenario. Fig. 3 and Fig. 4 show the real building prepared for the first and the second failure scenarios, respectively.

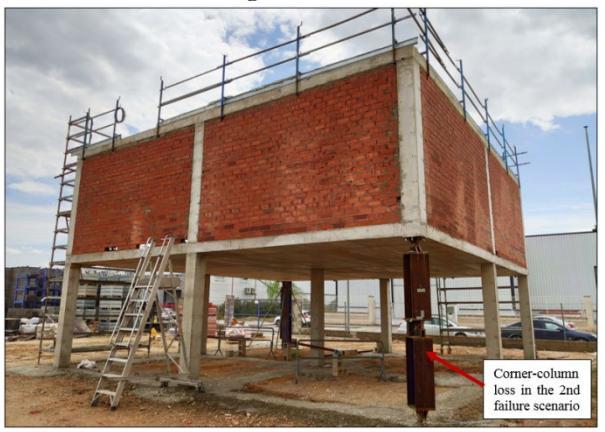
Figure 4. Building and definition of the second failure scenario.

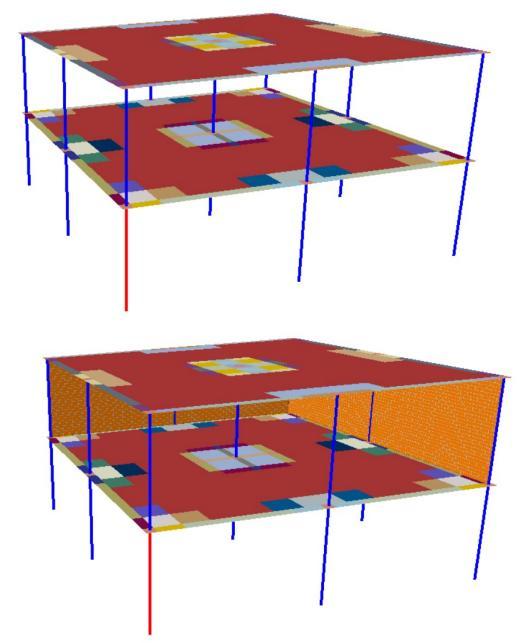
Figure 5. 3D view of the FE model without (top) and with infill masonry walls (bottom).

RC and steel columns were modelled as BEAM elements (B33) with an elastic behaviour, considering that cracking in the concrete columns should be reduced. SHELL elements (S4R) were used for flat slabs and the infill masonry walls. For the floors, different areas with different amount of reinforcement were considered according to the structure design. A concrete damage plasticity model was adopted to reproduce the non-linear behaviour and damage of the concrete, adopting those expressions given by EC-2 [16]. As a first approach, results for the model with infill masonry walls were not predicted due to the variability of the results according to the unknown mechanical properties and connections with the RC structure. This model will be performed as a future work based on the experimental tested mechanical properties of the materials and the results obtained from the test under the second failure scenario. Table 1 shows the parameters considered in this preliminary study.

The lower nodes of the concrete columns of the ground floor had restricted displacements and rotations, whereas those corresponding to the steel columns had restricted displacements and free rotations. Fig. 5 shows a 3D view of the FE model.

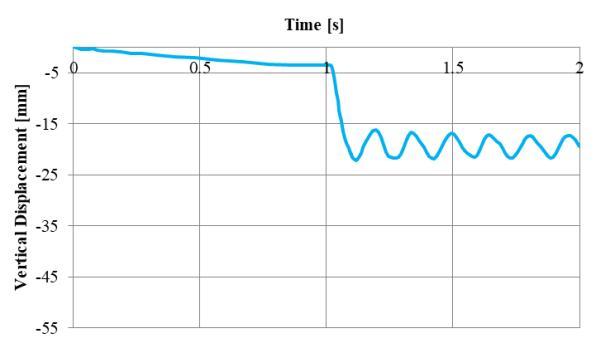
Fig. 6 and Fig. 7 show the timedependent vertical displacement predicted by the FEM in the center of the bay attached to failed column and in the upper point of this column for the first failure scenario, respectively. As it is shown, the RC structure achieves an important deflection after the accidental event within t = 1.0s and t = 2.0s. This response, as could be seen from the deformed shape (See Section 4.3), is governed by two main alternative load paths: a) bending; and b) Vierendeel action. Other alternative load paths, as membrane or arch action, were not activated in this case. Arch action can be activated when an external or internal column is lost, whereas membrane action is usually activated after the bending action, with high rotations at joints and a stiff horizontal restrain. In addition, Fig. 7 depicts the experimental results which were pretty similar to those predicted by the FEM during the design phase of the test.

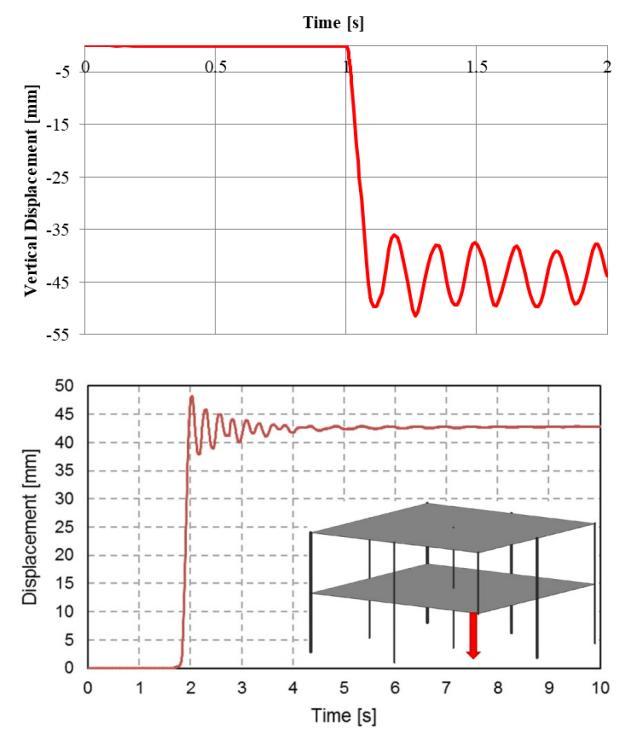
Figure 7. Position and time-history vertical displacements in the upper point of the failed column: predicted by the FE model (top) and registered in the test (bottom) without infill walls.

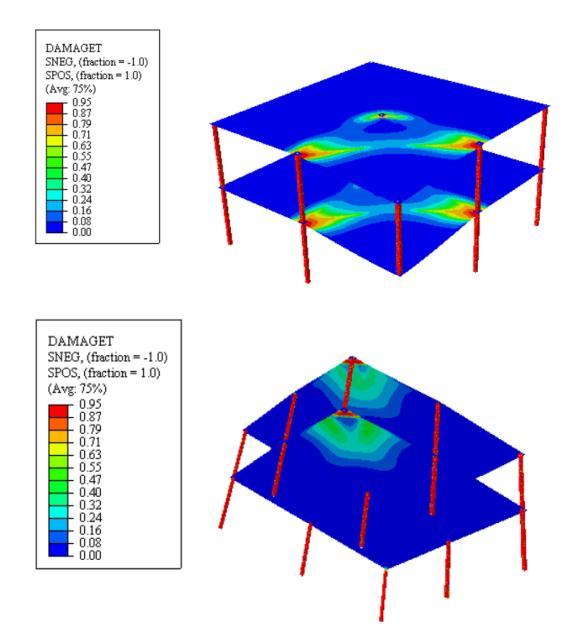
Figure 8. Predicted tensile damage of the upper (top) and lower (bottom) part of the RC slabs in the first failure scenario at 2.0s (deformed shape magnified 10 times).

Fig. 8 shows the predicted damage (cracking) on the upper and lower part of the RC slabs, respectively. As can be seen, this damage is localized in zones near the slabcolumn joints, where negative bending moments are important after the accidental event. Damage is also localized in the bottom part of the slabs near the failed column due to the flexural stresses introduced by the Vierendeel action. As an example of what occurred in the experimental test, Fig. 9 shows a photography of some cracks produced on the slabs near to the slab-column joint attached to the failed column after the accidental event.

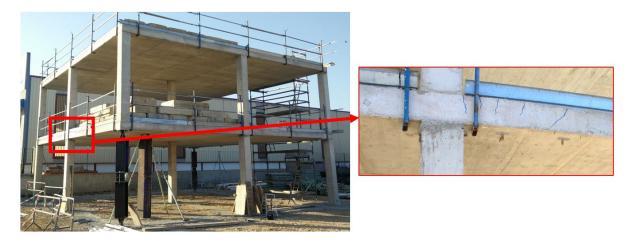
Figure 9. Cracks on the slabs near the slab-column joint next to the failed column after its sudden failure.

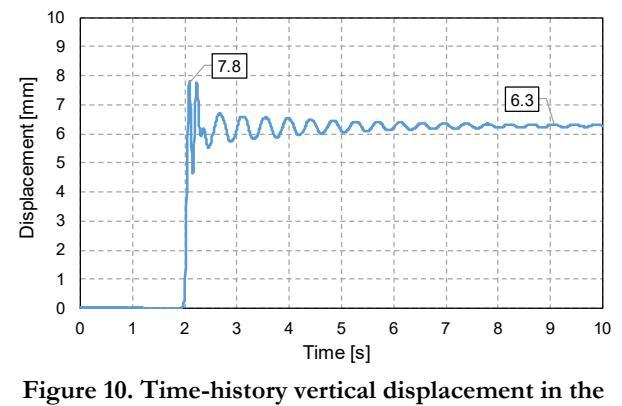
failed column with infill masonry walls.

The inclusion of the infill masonry walls produced a great influence in the structural response of the building. This can be seen from the vertical displacements in the upper point of the failed column (Fig. 10).

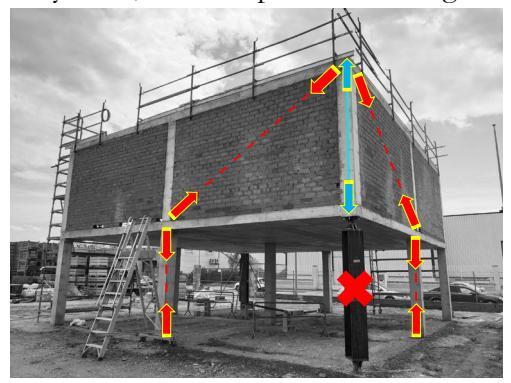
Figure 11. Activation of an alternative load path based on the infill masonry walls.

Results showed that the main alternative load path comprised the activation of the infill masonry walls, as it is represented in Fig. 11.

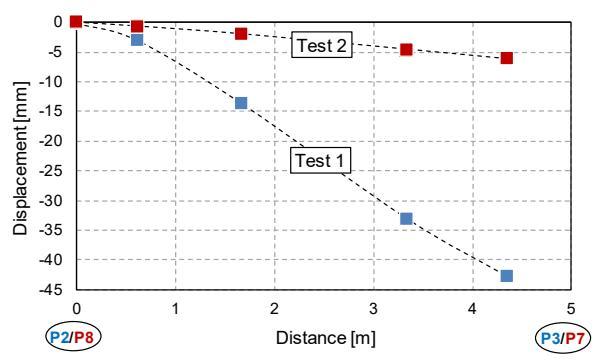
Figure 12. Vertical residual displacement (2D deformed shape) of the first floor between adjacent and failed columns for Test 1 (without infill walls) and Test 2 (with infill masonry walls).

A reduction of 83.8% was found in the maximum vertical displacement. Additionally, the structural response of the building changed, from the flexural and Vierendeel mechanisms (Test 1) to the main contribution of the infill masonry walls (Test 2).

Fig. 12 shows a comparison of the vertical displacements (deformed shape) for tests without (Test 1) and with (Test 2) infill masonry walls.
